THE **BOEING** COMPANY
AERO-SPACE DIVISION
LAUNCH SYSTEMS BRANCH

DOCUMENT NO. T5-6539-86

TITLE ANALYSIS OF FAILURE OF SHAFT FROM THE LOX INTER CONNECT
VALVE, 60B41005-1

MODEL NO. SAT V/S-IC CONTRACT NO. NAS8-5608

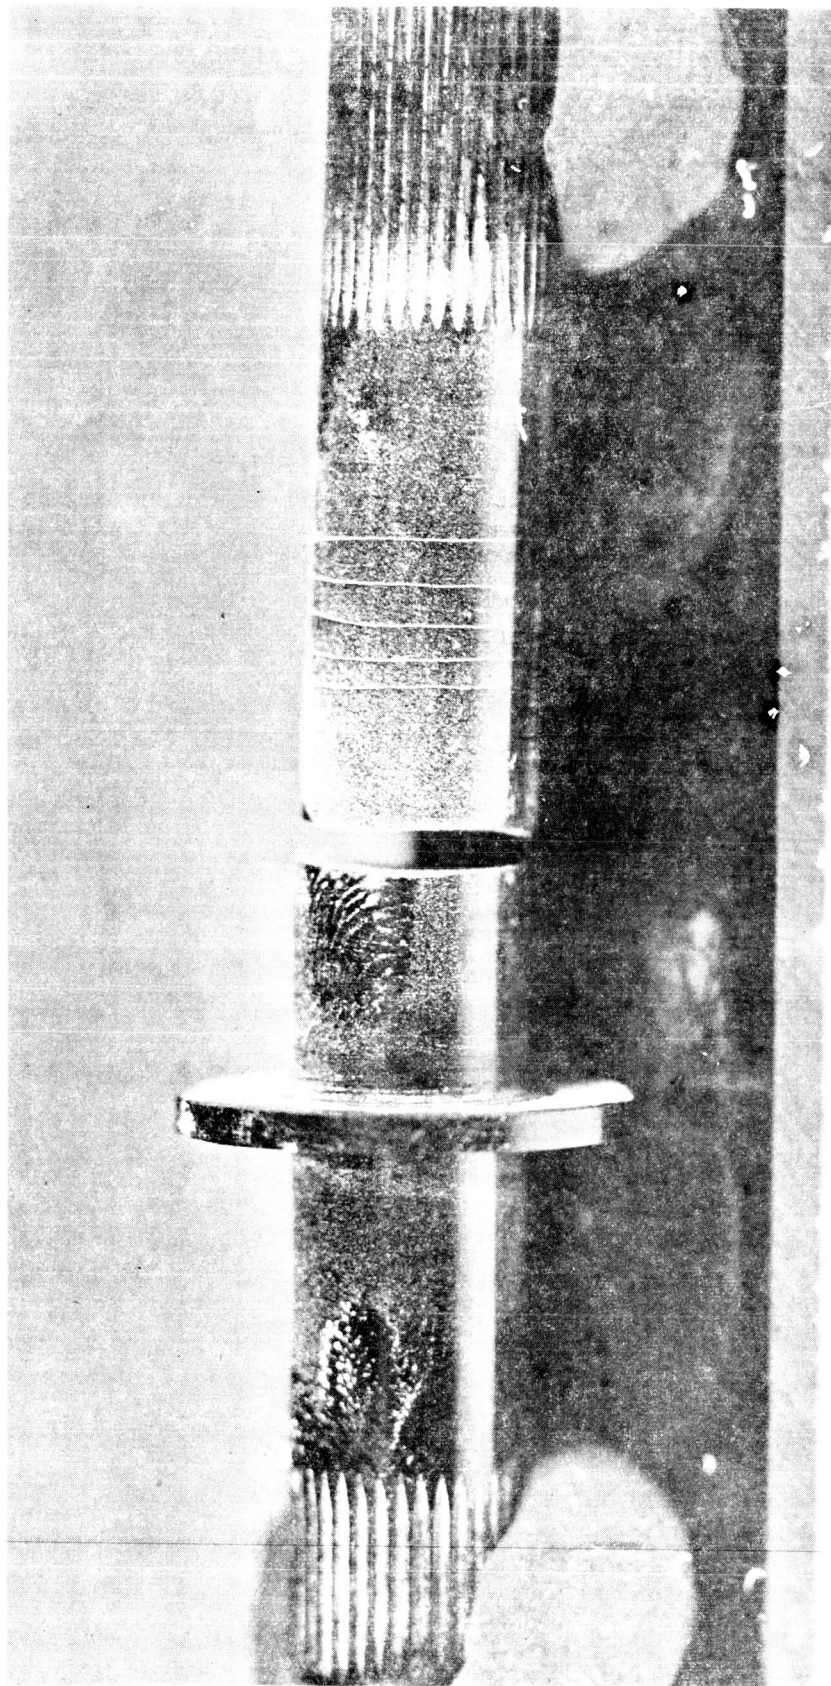
Figure #1

- 1) The broken shaft was given a magnetic inspection and photographed. In addition to the failed area 5 cracks were observed. (Figure #1).
- 2) The fractographic study indicates a failure in a bending manner. (not torsional) Six distinct areas of failure can be observed on the fracture face. (Figure #2).
- 3) The shaft was cross sectioned and the cross section photographed (Photo # 1). Note: the depth of the cracks revealed in magnetic inspection. Photos # 2 and 3 show one of these cracks at greater magnification. Note the intergranular nature. Overload failure would show transgranular failure.

Photo of Magnetic Indications on Shaft

- 1) All shafts should be given a magnetic inspection prior to installation and rejected if defects are seen.
- 2) The condition of all installed shafts should be determined if possible.
- 3) Grinding practice should be controlled to preclude overheating and development of untempered martensite and resultant cracks or crack sensitive structure.
- 4) An Austenitic type material would be more compatible to a cryogenic atmosphere.

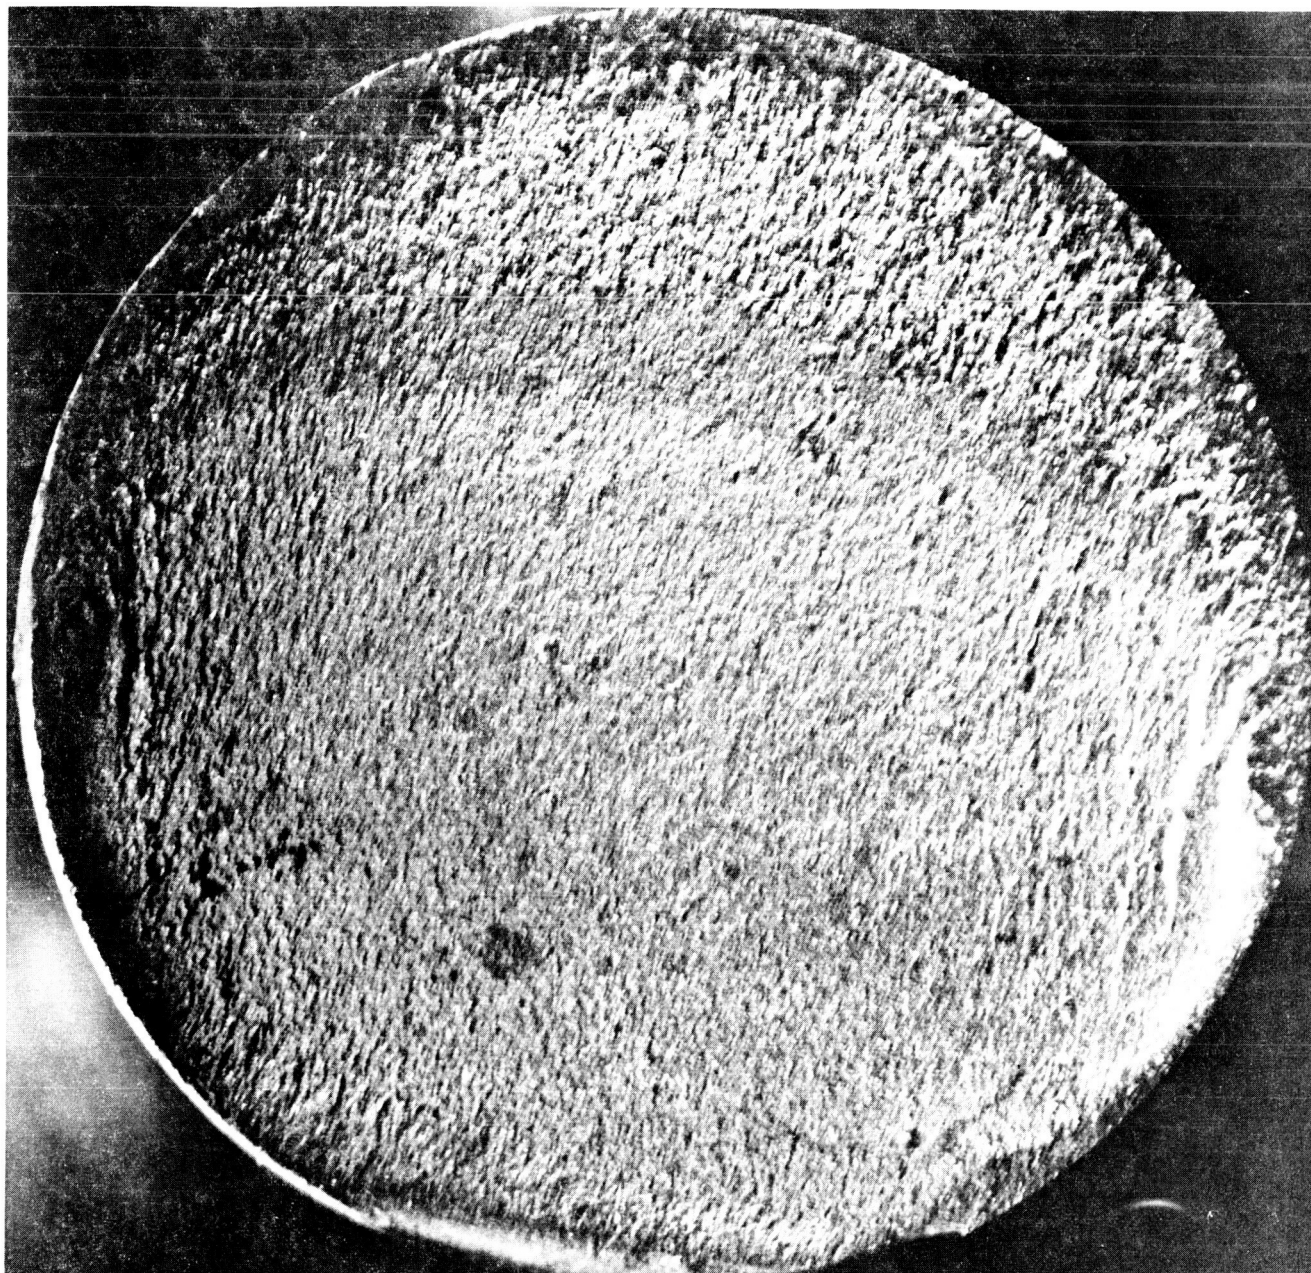
Figure #2

Fracture Face of Shaft

Note Stages of Progressive Failure

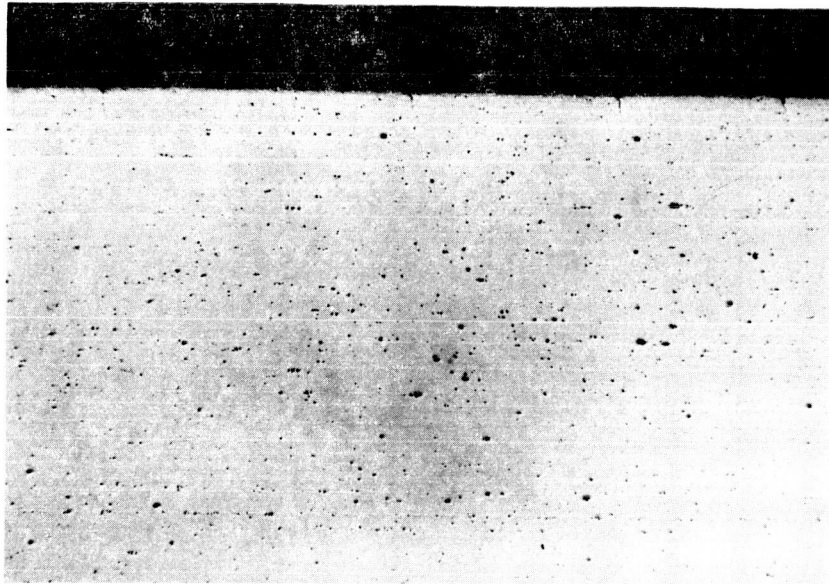
Photo #1

Cross Section of Magnetic Indications (8X)

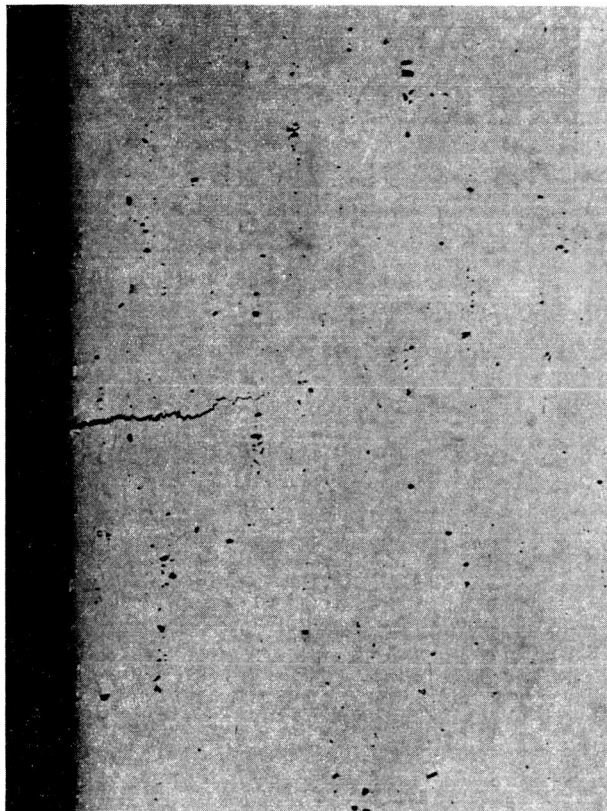
Photo #2

Cross Section (100X)

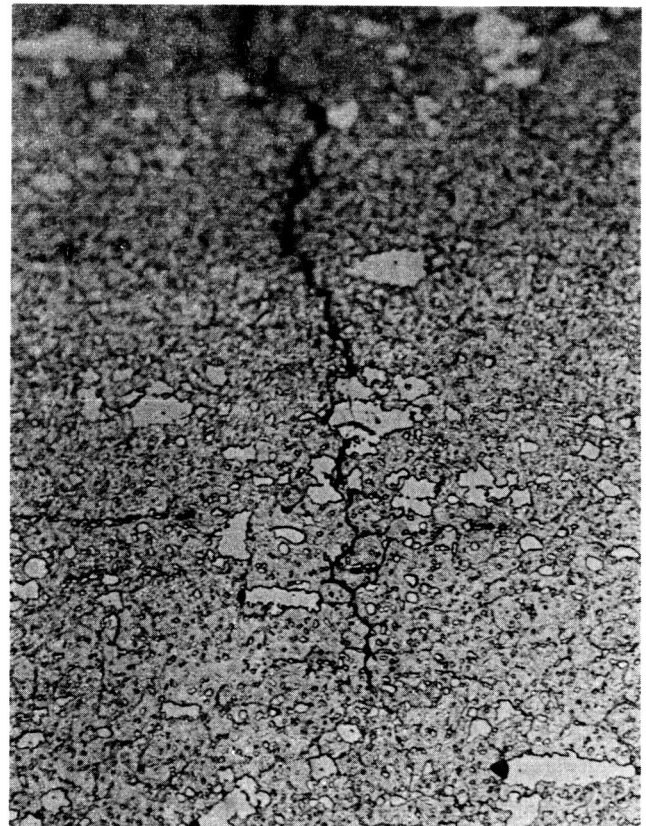
Photo #3

Cross Section (500X)

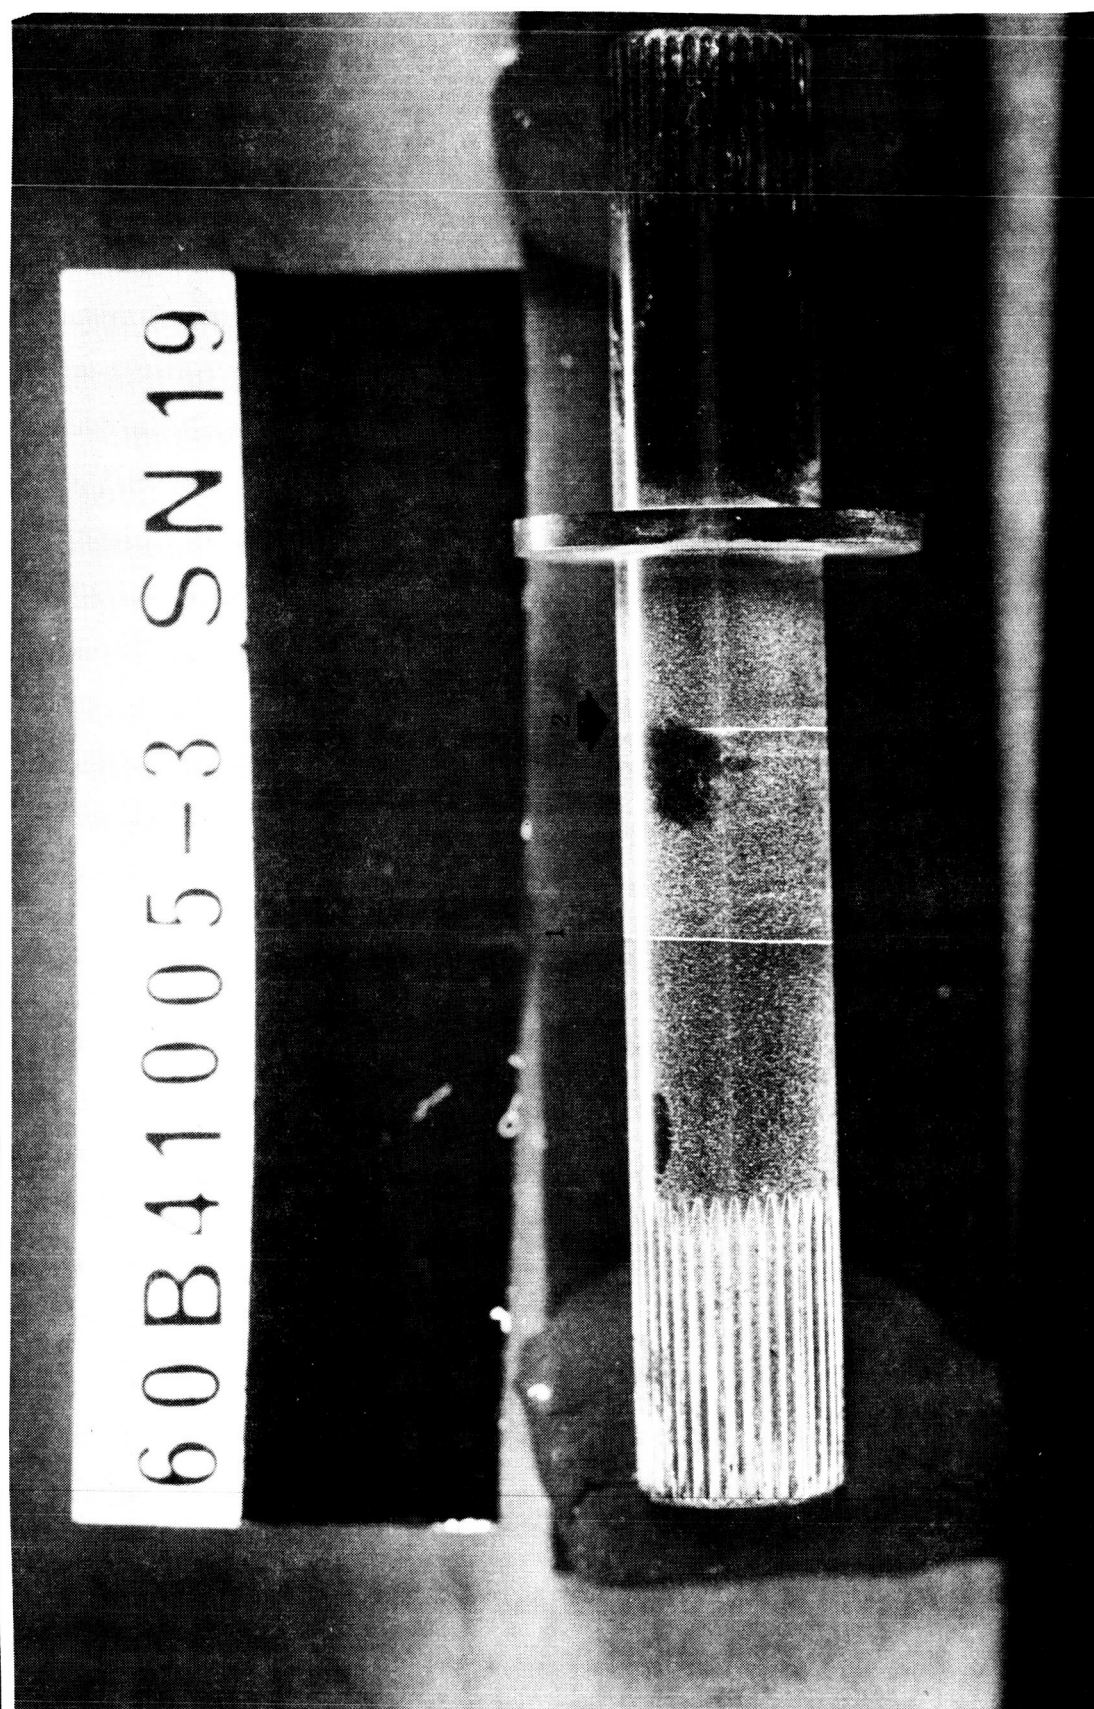
FIGURE # 1

Magnetic inspection of the shafts revealed cracks in S/N 19, identical to those reported on previous failed shafts. (Figure #1). This shaft was sectioned and microscopically inspected. Photo A and B of Figure #2 show the extent of failure of this shaft. Crack #1 was much longer than those previously observed. No cracks were seen on any of the other shafts inspected. Photo C of Figure #2 shows the intergranular mode of propagation of the #1 crack.

Magnetic Particle Indications on Failed Shaft.

NOTE: Crack #2 indicated by arrow does not extend completely around shaft.

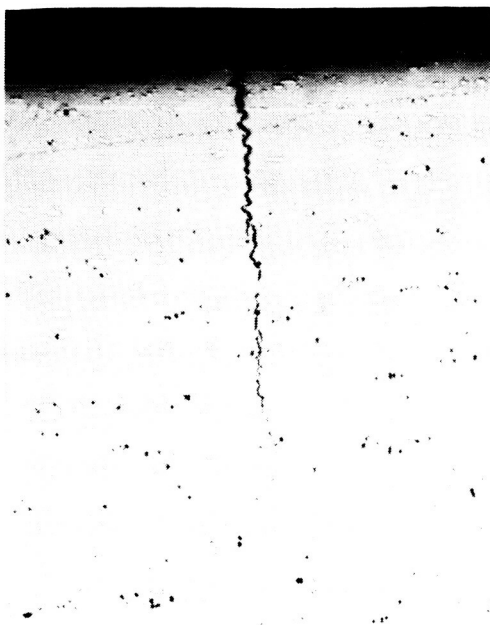
The cracked shaft (S/N 19) was close to catastrophic failure.

PHOTO A 100X
 Cross Section of Crack # 1.
 Note that this crack is much
 more extensive than those
 previously observed.

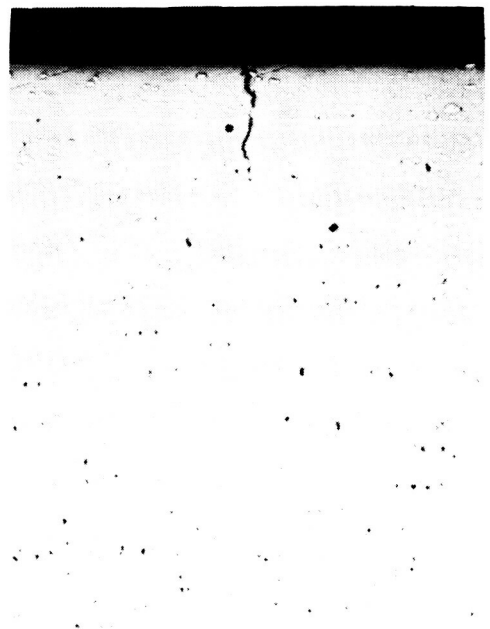
PHOTO B 100X
 Cross Section of Crack # 2.

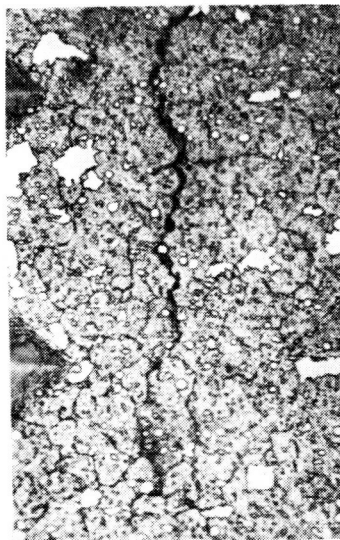
PHOTO C 500X
 Etched Section of Crack # 1.
 Note intergranular mode of
 propagation.
